**THE PLACE DAM  
WASHINGTON COUNTY, MISSOURI  
MO 30996**

**PHASE 1 INSPECTION REPORT  
NATIONAL DAM SAFETY INSPECTION**

**DECEMBER 1980**

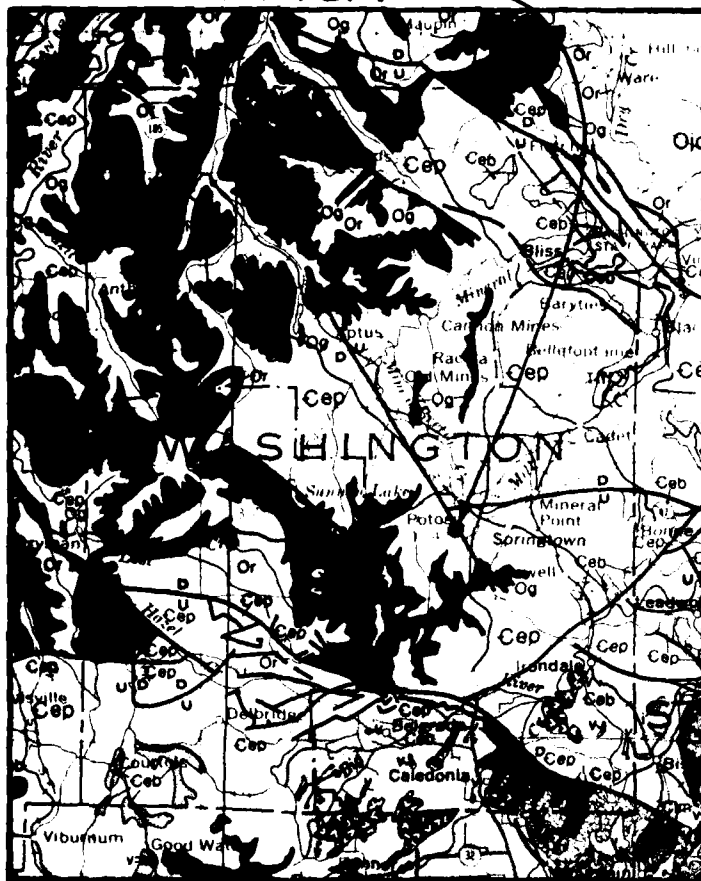
Fig. 4

The Aptus Fault is mapped on the Geologic Map of Missouri (1979) as directly beneath the dam (Fig 4). However, the scale of the map (1 in. equals 8 mi) does not allow for precise location of the fault trace. No evidence of the fault was noted during the field inspection. The fault is approximately 15 mi long, trending northwest-southeast. The fault is mapped as northeast side up.

This fault, like others in the Ozark region, appears confined to the Paleozoic bedrock and is likely Paleozoic in age. The area is not considered seismically active. However, the presence of a fault in the immediate vicinity, and perhaps underlying the dam, suggests further study is necessary to evaluate such possible hazards as the potential for groundwater solutioning along the fault in the foundation of this dam.

2. A study should be conducted of the Aptus Fault, as described in this report in Section 2.5, Project Geology, to determine the location of the trace of this fault and to evaluate whether or not it represents any potential safety hazard to the dam.
